Manhole Inspection Summary

Manhole # S19GG2077MH

Record Plat: **19GG2** Node: **077** Status: **New Manhole (Not in GIS)** Insp Date: **4/24/07 12:00 AM**

Location Address: **5928 FALLS RD** Cross Street: **WASHINGTONVILLE DR**

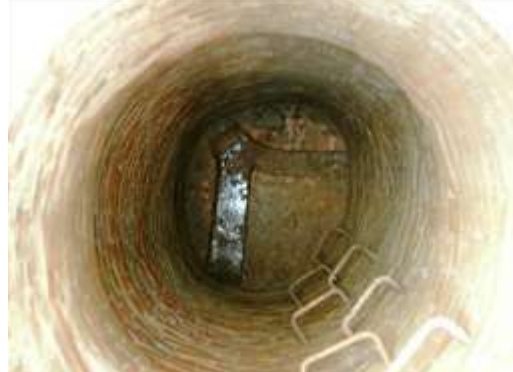
Top View

Corroded steps. Evidence of surcharge - Bench debris. Channel debris.

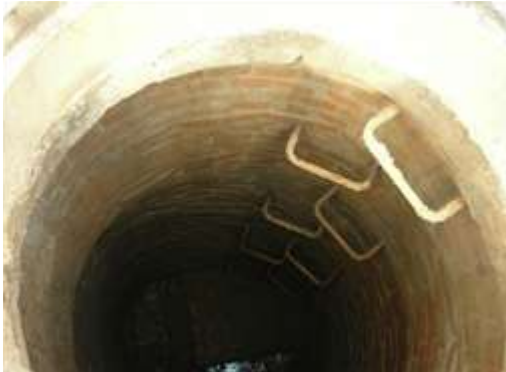
Defect

Frame leaks. Adjustment deterioration and infiltration. Corbel and Barrel infiltration - other side.

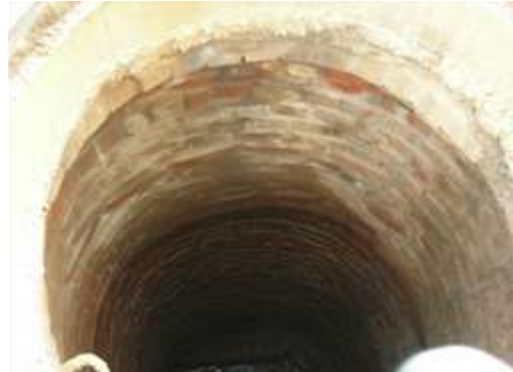
Defect

Frame leaks. Adjustment deterioration and infiltration. Corbel and Barrel infiltration

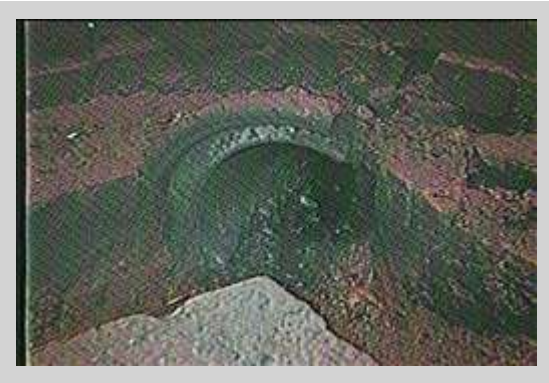
8 in. Circular Gravity Sewer Pipe Out @ 12 O'Clock

Barrel deterioration and infiltration.

Deposits: ☐ None ☒ **Mud** ☐ Sludge ☒ **Debris** ☐ Grease

Silt Depth: **1** (in.) Deposits Extent: **Light**

Infiltration: **Evidence** Pipe Seal Cond: **Broken**

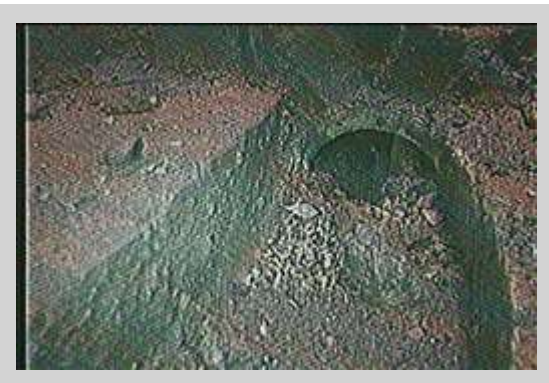
8 in. Circular Gravity Sewer Pipe In @ 4 O'Clock

Deposits: ☐ None ☒ **Mud** ☐ Sludge ☒ **Debris** ☐ Grease

Silt Depth: **3** (in.) Deposits Extent: **Medium**

Infiltration: **None** Pipe Seal Cond: **Cracked**

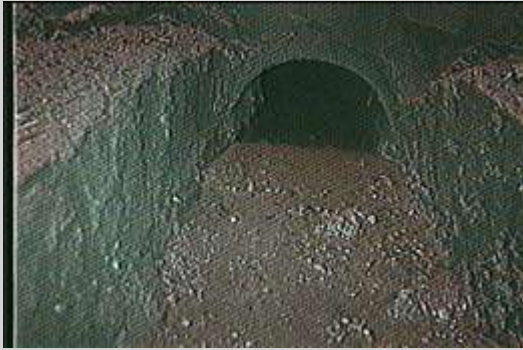
Pipe In @ 7 O'Clock

Deposits: ☐ None ☒ **Mud** ☐ Sludge ☒ **Debris** ☐ Grease

Silt Depth: **3** (in.)

Deposits Extent: **Medium**

Pipe Seal Cond: **Cracked**
